**Flood Control Project Maintenance  
Levee Inspections**

**Fall 2013 Levee Maintenance Deficiency Summary Report**

**Flood Control Project Maintenance  
Levee Inspections  
LMA District Cover Sheet  
Fall 2013 Levee Inspection Results**

**Reclamation District No. 0003 Grand Island**

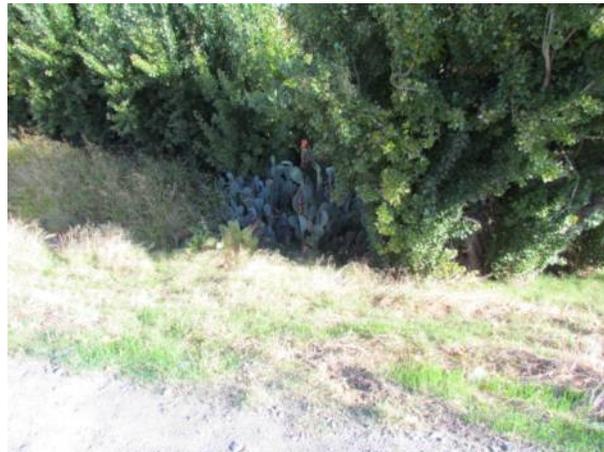
Levee Mile Report Line	16
Start Levee Mile	2.50
End Levee Mile	2.50
Location	Land Side
Category	Earthen Levee
Item	Vegetation
Looking west at cactus on landward toe.	
richard_f_20131011_063.JPG

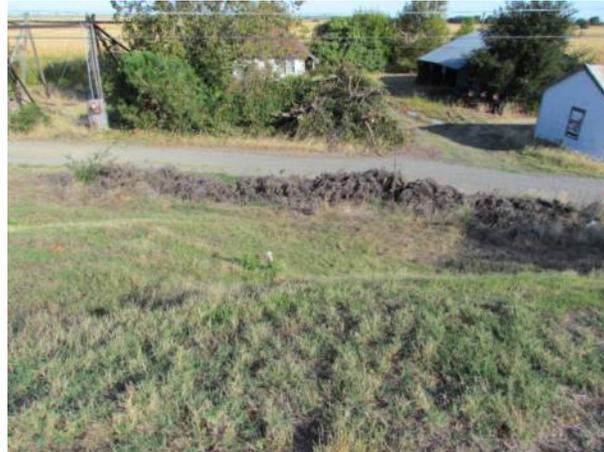
Levee Mile Report Line	18
Start Levee Mile	2.86
End Levee Mile	2.86
Location	Land Side
Category	Earthen Levee
Item	Encroachments
Looking west at pruning piles on landward toe.	
richard_f_20131011_064.JPG

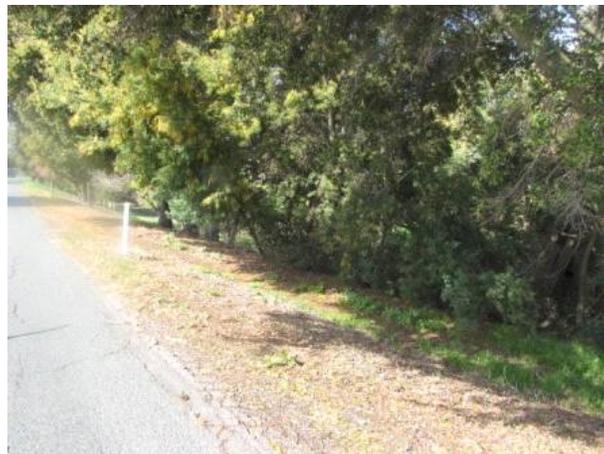
Levee Mile Report Line	21
Start Levee Mile	3.29
End Levee Mile	3.29
Location	Land Side
Category	Earthen Levee
Item	Trim / Thin Trees
Looking west at dense vegetation on landside slope and toe.	
richard_f_20130918_152.jpg

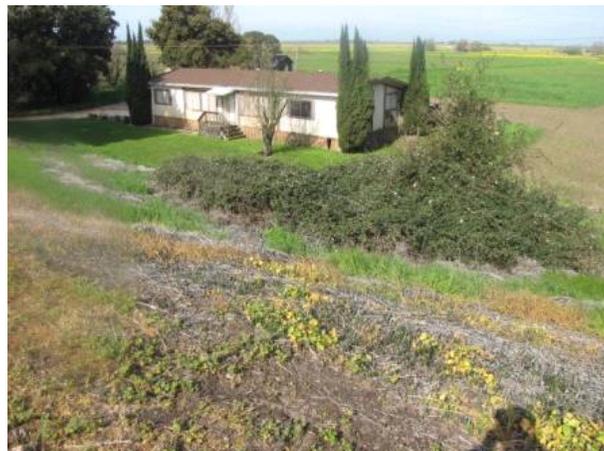
Levee Mile Report Line	22
Start Levee Mile	3.32
End Levee Mile	3.32
Location	Land Side
Category	Earthen Levee
Item	Vegetation
Looking west at berryvines on landside toe.	
richard_f_20130918_177.jpg

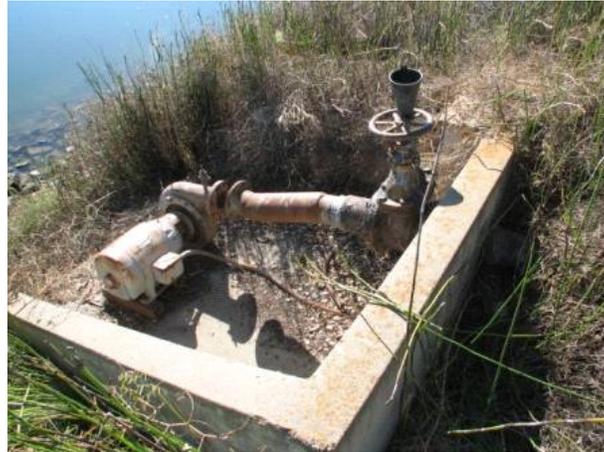
Levee Mile Report Line	23
Start Levee Mile	3.39
End Levee Mile	3.39
Location	Water Side
Category	Earthen Levee
Item	Encroachments
Pipe penetration, closure valve in open position.	
richard_f_20130918_178.jpg

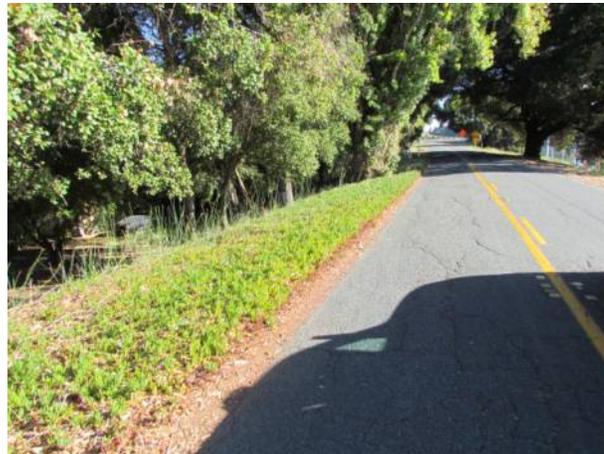
Levee Mile Report Line	24
Start Levee Mile	3.41
End Levee Mile	3.41
Location	Land Side
Category	Earthen Levee
Item	Vegetation
Looking northwest at landscaping blocking view of landward slope.	
richard_f_20131011_065.JPG

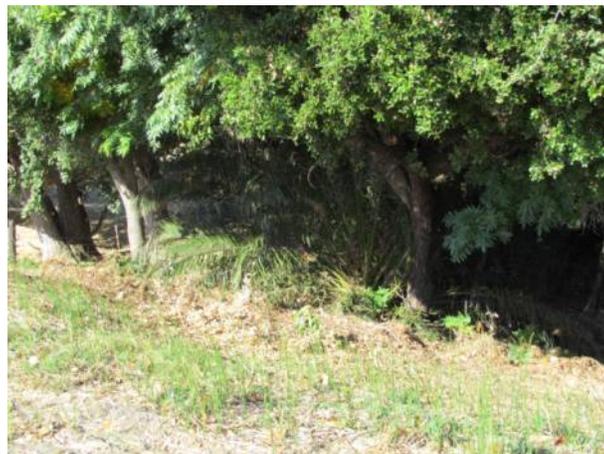
Levee Mile Report Line	25
Start Levee Mile	3.56
End Levee Mile	3.56
Location	Land Side
Category	Earthen Levee
Item	Vegetation
Looking west at plum tree on landward toe.	
richard_f_20131011_066.JPG

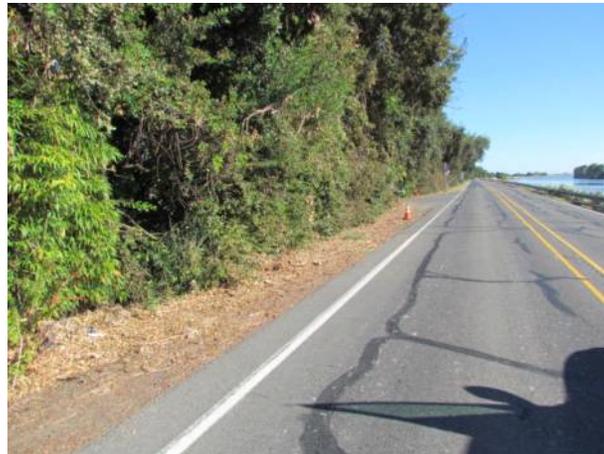
Levee Mile Report Line	29
Start Levee Mile	3.90
End Levee Mile	3.92
Location	Land Side
Category	Earthen Levee
Item	Trim / Thin Trees
Looking northwest at dense trees on landward shoulder and slope.	
richard_f_20131011_067.JPG

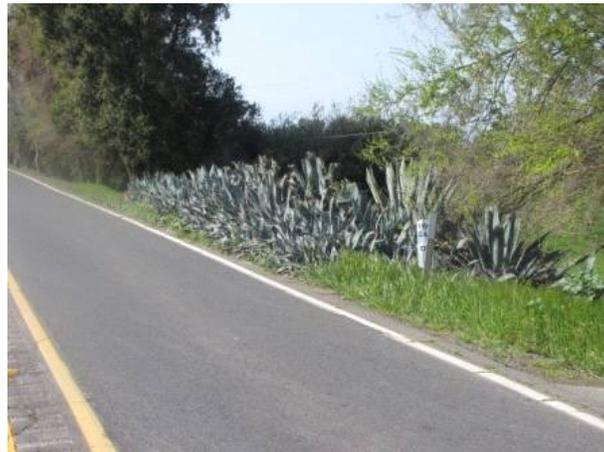
Levee Mile Report Line	30
Start Levee Mile	4.22
End Levee Mile	4.22
Location	Land Side
Category	Earthen Levee
Item	Vegetation
Looking west at cactus on landside slope.	
richard_f_20130918_162.jpg

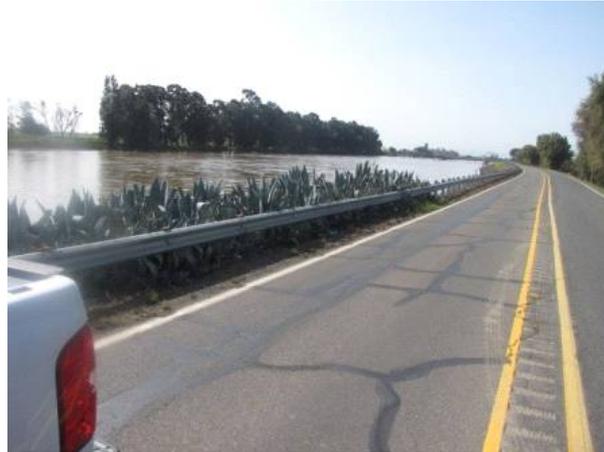
Levee Mile Report Line	30
Start Levee Mile	4.22
End Levee Mile	4.22
Location	Land Side
Category	Earthen Levee
Item	Vegetation
Looking southeast a cactus on waterside shoulder and slope.	
richard_f_20130918_163.jpg

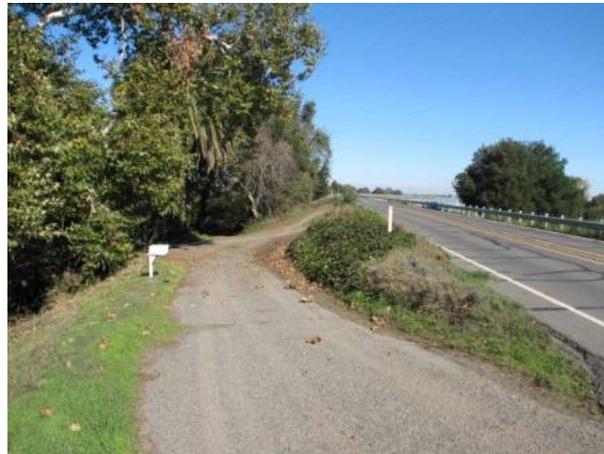
Levee Mile Report Line	33
Start Levee Mile	4.36
End Levee Mile	4.42
Location	Land Side
Category	Earthen Levee
Item	Vegetation
Landscaping on levee slope and toe obstructs access and visibility.	
richard_f_20130918_205.jpg

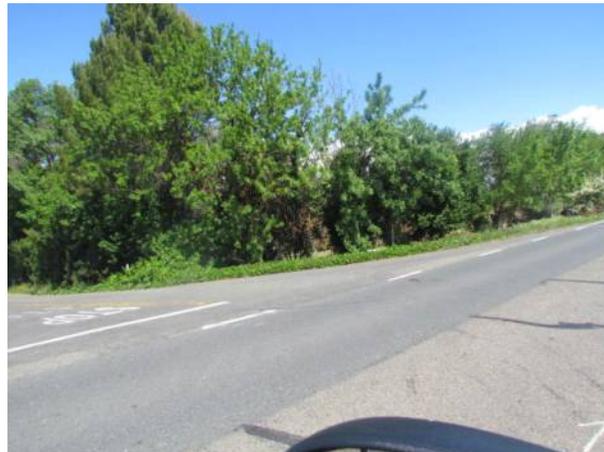
Levee Mile Report Line	36
Start Levee Mile	4.72
End Levee Mile	4.80
Location	Land Side
Category	Earthen Levee
Item	Vegetation
Looking west at dense vegetation on landward slope.	
richard_f_20130918_160.JPG

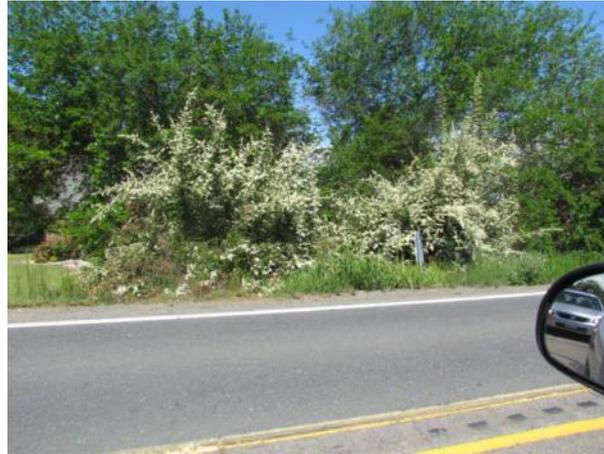
richard\_f\_20130918\_161.JPG

Looking west at vegetation on landward shoulder.

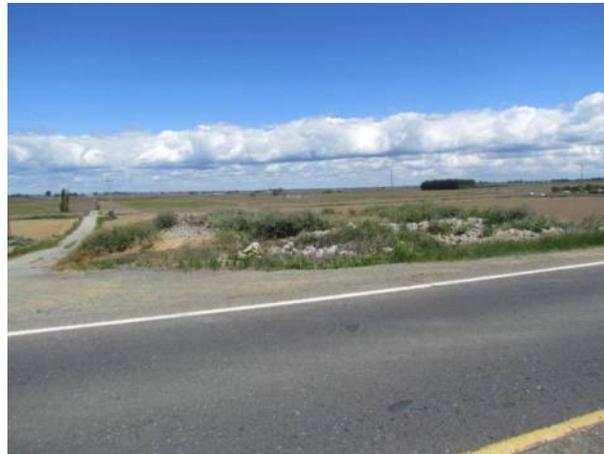
Levee Mile Report Line	39
Start Levee Mile	5.48
End Levee Mile	5.48
Location	Land Side
Category	Earthen Levee
Item	Encroachments

Looking west at concrete rubble on landward shoulder and slope.

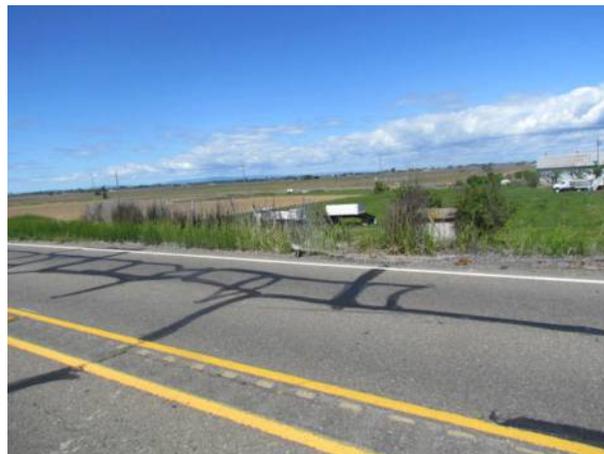
richard\_f\_20130918\_168.JPG

Looking west at cyclone fence on landward shoulder.

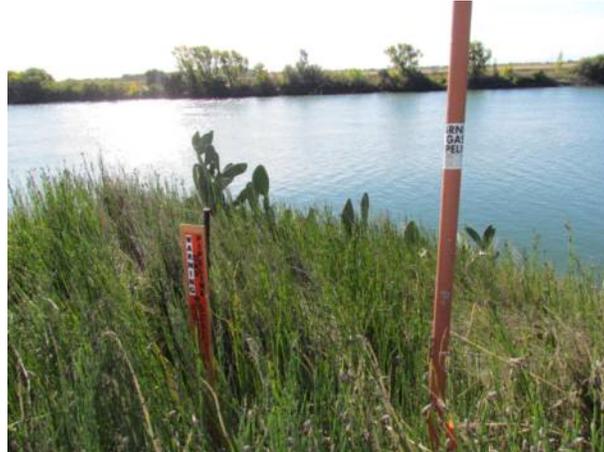
Levee Mile Report Line	41
Start Levee Mile	5.72
End Levee Mile	5.72
Location	Water Side
Category	Earthen Levee
Item	Vegetation
Looking east at dense vegetation and cactus on waterward slope.	
richard_f_20131011_068.JPG

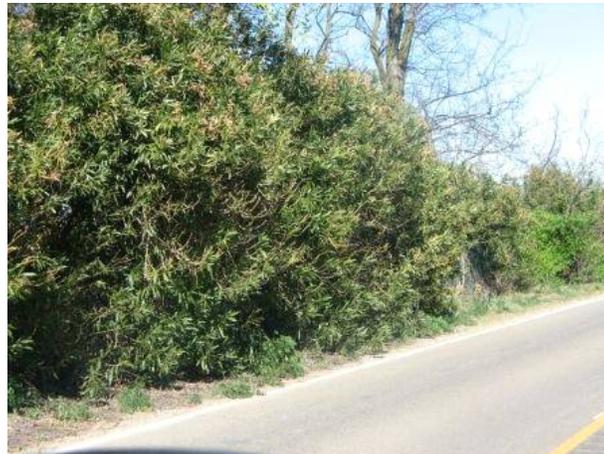
Levee Mile Report Line	42
Start Levee Mile	5.94
End Levee Mile	6.00
Location	Land Side
Category	Earthen Levee
Item	Vegetation
Oleander on landside shoulder blocking view of levee slope from LM 5.94 to 6.00	
richard_f_20130918_155.jpg

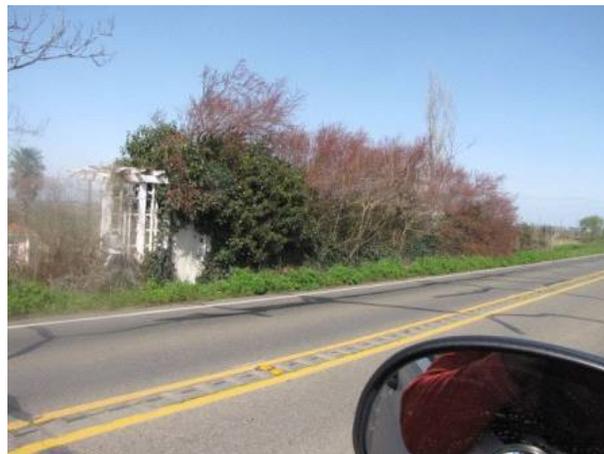
Levee Mile Report Line	47
Start Levee Mile	7.38
End Levee Mile	7.38
Location	Land Side
Category	Earthen Levee
Item	Vegetation
Looking northwest a dense landscaping on landside shoulder and slope.	
richard_f_20130918_180.jpg

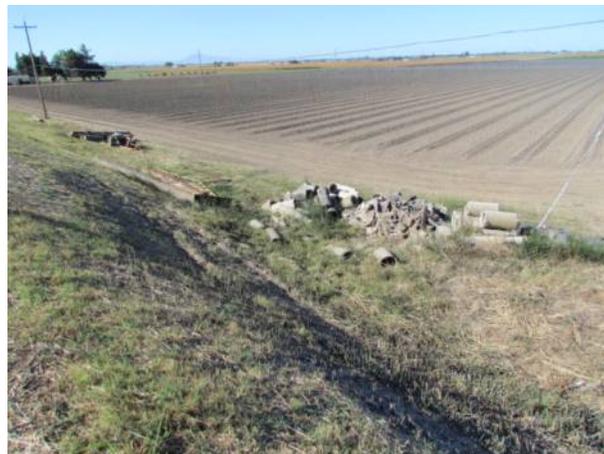
Levee Mile Report Line	49
Start Levee Mile	8.03
End Levee Mile	8.03
Location	Land Side
Category	Earthen Levee
Item	Encroachments
Looking west at broken concrete pipes and farm equipment at landward toe.	
richard_f_20131011_069.JPG

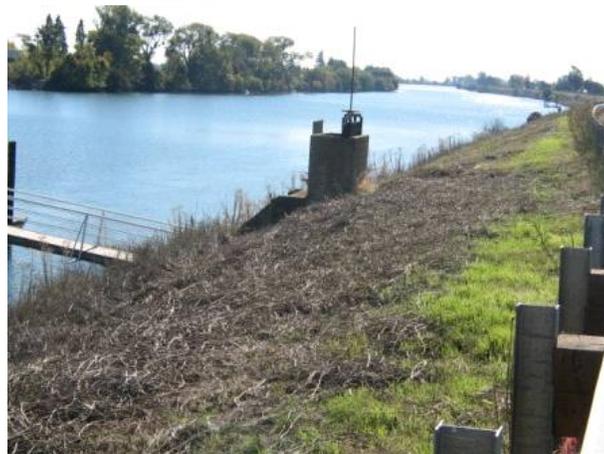
Levee Mile Report Line	51
Start Levee Mile	8.27
End Levee Mile	8.27
Location	Water Side
Category	Earthen Levee
Item	Encroachments
Photo of tunnel through levee.	
richard_f_20130918_182.jpg

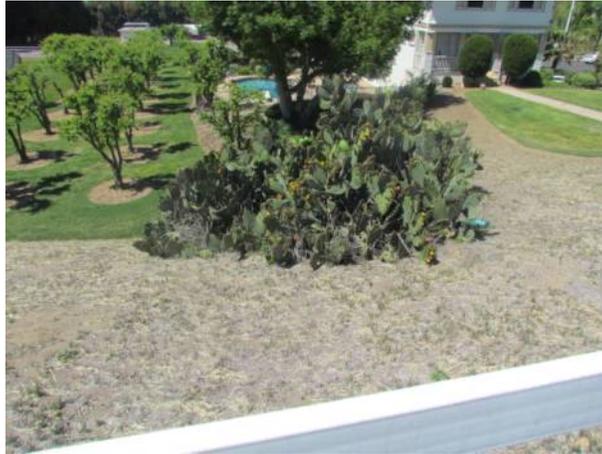
richard\_f\_20130918\_198.JPG

Looking west at cactus on landward slope and toe.

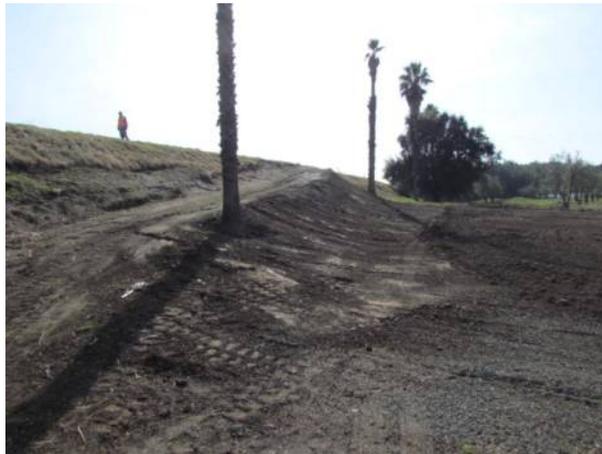
richard\_f\_20130918\_148.jpg

Looking south at unauthorized ramp on landside slope.

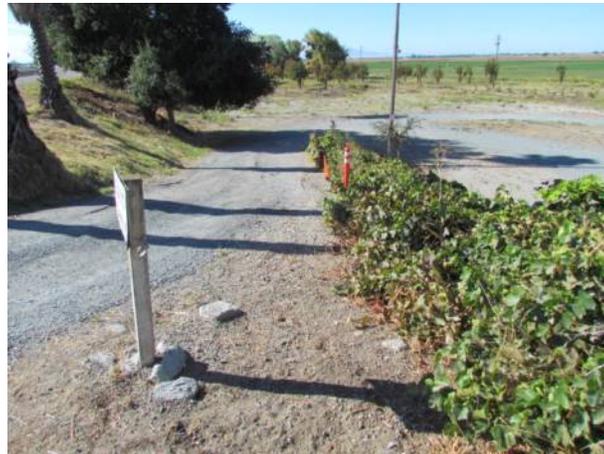
Levee Mile Report Line	57
Start Levee Mile	9.19
End Levee Mile	9.19
Location	Land Side
Category	Earthen Levee
Item	Encroachments
Looking southwest at unauthorized ramp on landside. 2013	
richard_f_20131011_070.JPG

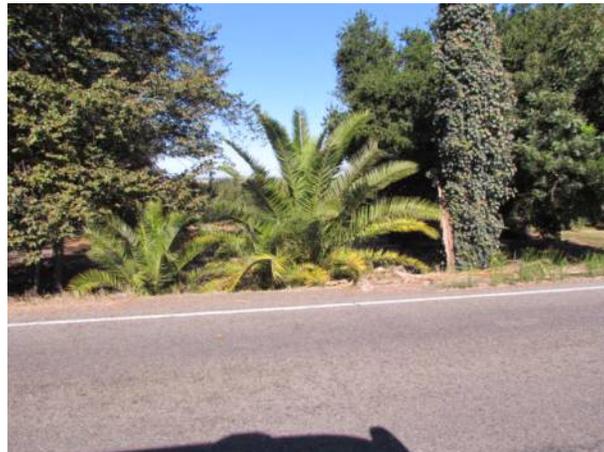
Levee Mile Report Line	60
Start Levee Mile	9.37
End Levee Mile	9.37
Location	Land Side
Category	Earthen Levee
Item	Vegetation
Looking west at plam trees on landward shoulder and slope.	
richard_f_20131011_071.JPG

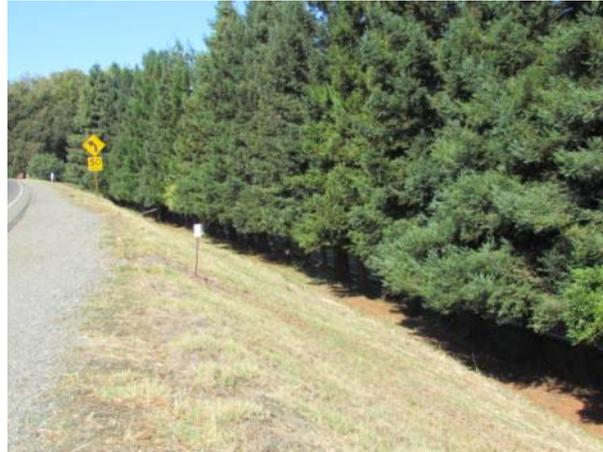
Levee Mile Report Line	64
Start Levee Mile	9.87
End Levee Mile	9.99
Location	Land Side
Category	Earthen Levee
Item	Trim / Thin Trees
Looking southwest at dense redwood trees on landward toe and berm.	
richard_f_20131011_072.JPG

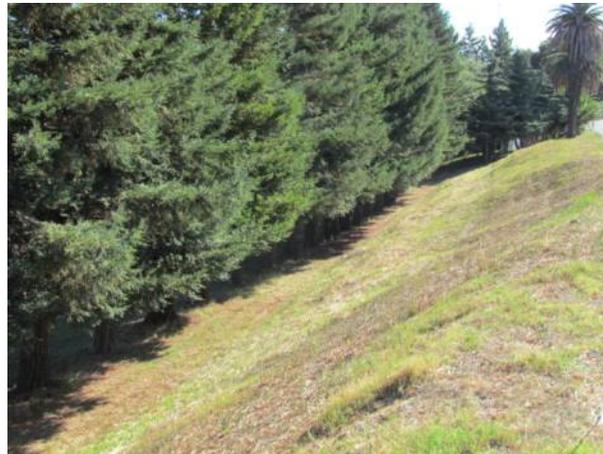
Levee Mile Report Line	64
Start Levee Mile	9.87
End Levee Mile	9.99
Location	Land Side
Category	Earthen Levee
Item	Trim / Thin Trees
Looking northwest at dense redwood trees on landward toe and berm.	
richard_f_20131011_073.JPG

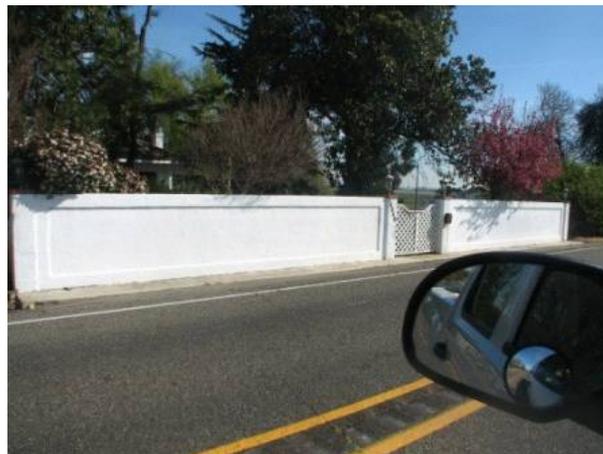
Levee Mile Report Line	66
Start Levee Mile	10.13
End Levee Mile	10.13
Location	Land Side
Category	Earthen Levee
Item	Encroachments
Block/Concrete fence on landside shoulder at LM 10.13	
richard_f_20130918_165.jpg

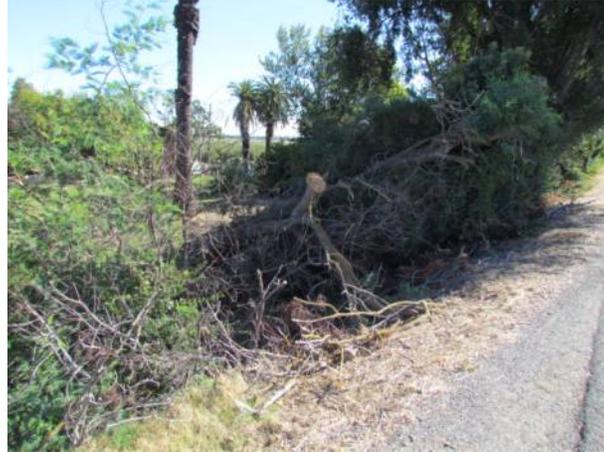
richard\_f\_20131011\_074.JPG

Looking west at down tree on landward slope.

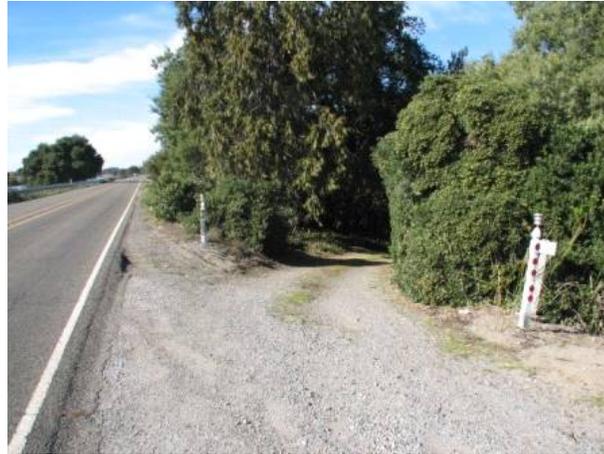
richard\_f\_20130918\_184.jpg

Levee Mile Report Line	71
Start Levee Mile	10.74
End Levee Mile	10.74
Location	Land Side
Category	Earthen Levee
Item	Vegetation

Landscaping on levee slope and toe obstructs access and visibility.

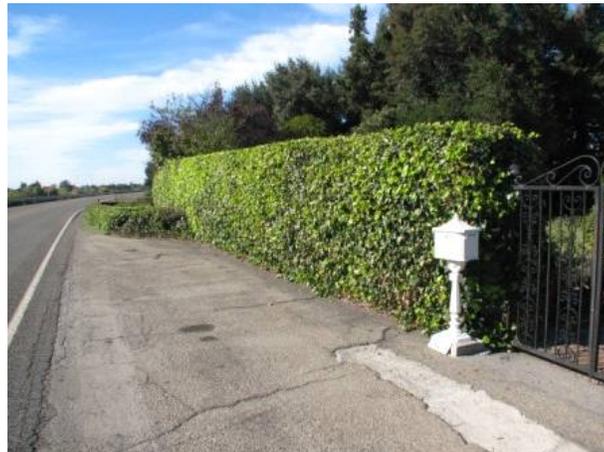
richard\_f\_20130918\_185.jpg

Levee Mile Report Line	72
Start Levee Mile	10.98
End Levee Mile	10.98
Location	Land Side
Category	Earthen Levee
Item	Vegetation

Landscaping on levee slope obstructs access and visibility.

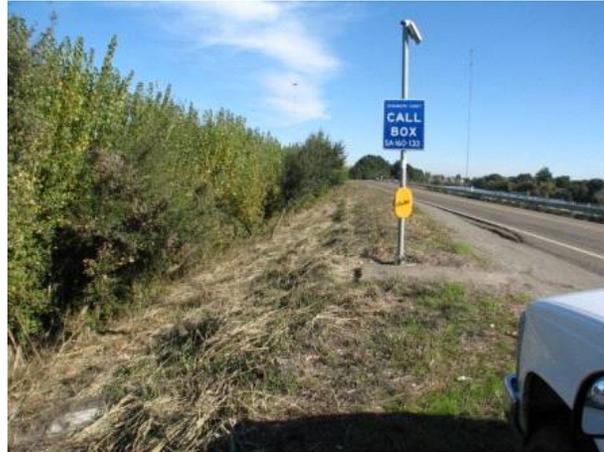
Levee Mile Report Line	74
Start Levee Mile	11.12
End Levee Mile	11.35
Location	Land Side
Category	Earthen Levee
Item	Vegetation
Landscaping trees on levee slope an toe obstruct access and visibility.	
richard_f_20130918_186.jpg

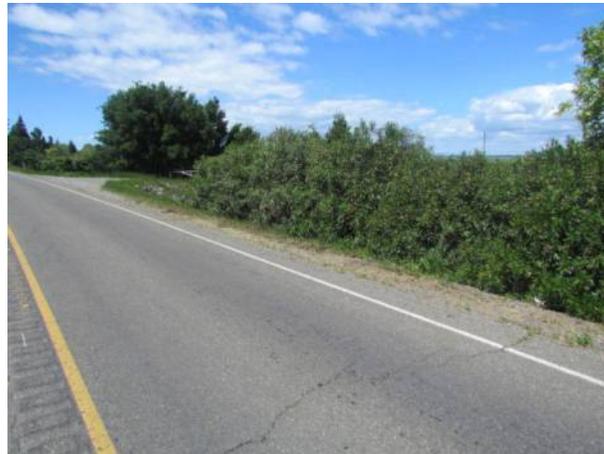
Levee Mile Report Line	75
Start Levee Mile	11.31
End Levee Mile	11.31
Location	Land Side
Category	Earthen Levee
Item	Vegetation
Looking southwest at dense landscaping on landward shoulder and slope.	
richard_f_20130918_201.JPG

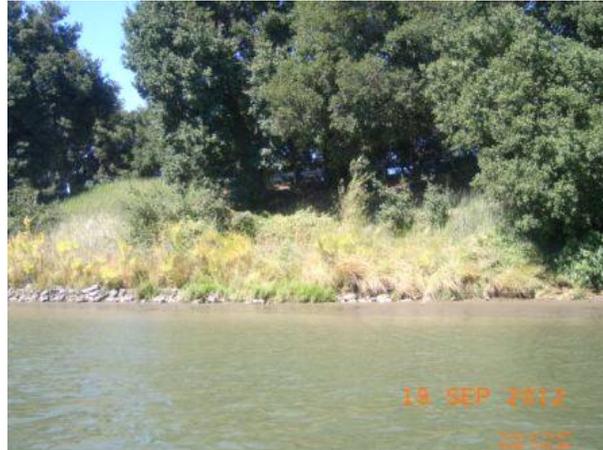
Levee Mile Report Line	76
Start Levee Mile	11.33
End Levee Mile	11.33
Location	Water Side
Category	Supplemental
Item	USACE Erosion Survey
USACE 2012 Photo #2	
USACE2013_SAC_26-3_R_2.jpg

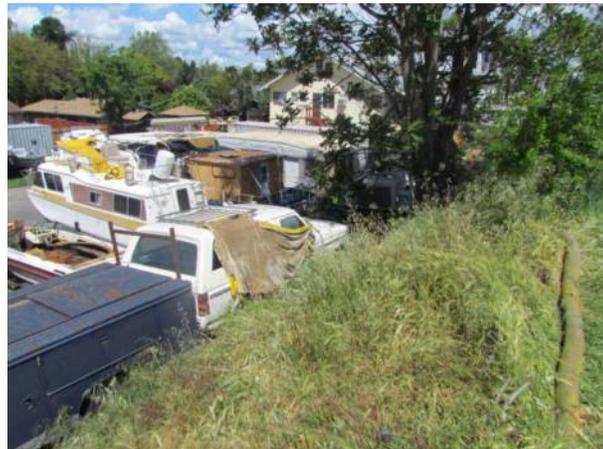
Levee Mile Report Line	83
Start Levee Mile	12.12
End Levee Mile	12.12
Location	Land Side
Category	Earthen Levee
Item	Encroachments
Looking northwest at abandoned vehicles on landward toe.	
richard_f_20130918_202.JPG

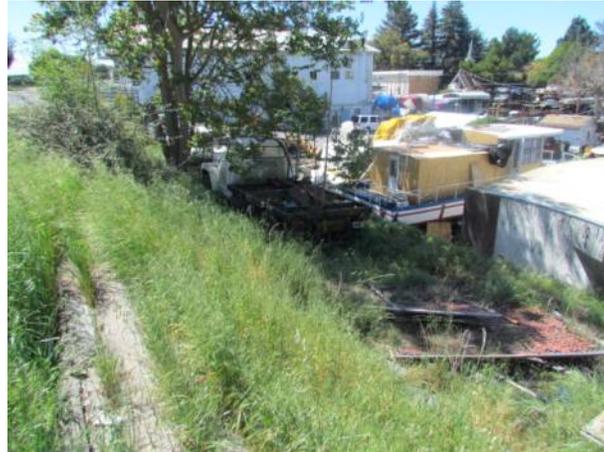
Levee Mile Report Line	83
Start Levee Mile	12.12
End Levee Mile	12.12
Location	Land Side
Category	Earthen Levee
Item	Encroachments
Looking southwest at abandoned vehicles and material on landward slope and toe.	
richard_f_20130918_203.JPG

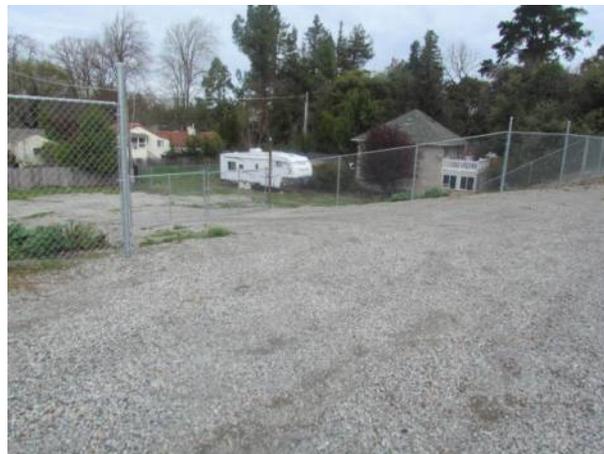
Levee Mile Report Line	84
Start Levee Mile	12.21
End Levee Mile	12.21
Location	Land Side
Category	Earthen Levee
Item	Encroachments
Looking northwest at new ramp on landside slope.	
richard_f_20130918_207.jpg

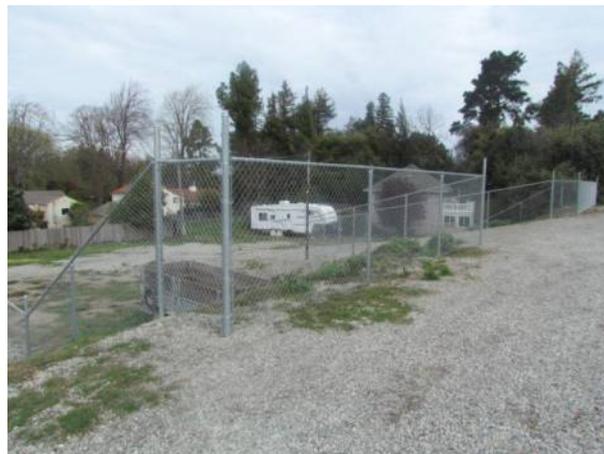
Levee Mile Report Line	85
Start Levee Mile	12.21
End Levee Mile	12.21
Location	Land Side
Category	Earthen Levee
Item	Encroachments
Looking northwest at new fence on landside shoulder and slope.	
richard_f_20130918_206.jpg

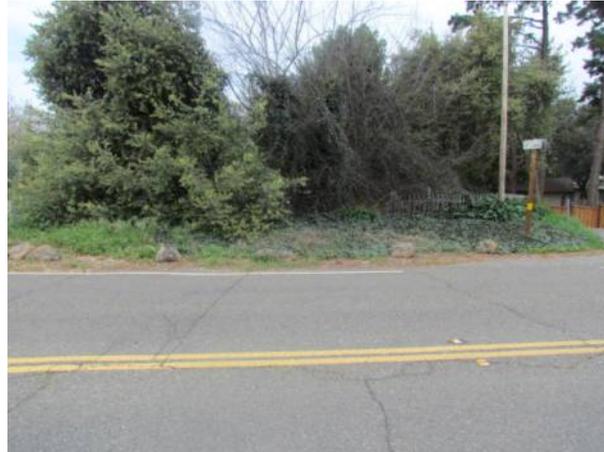
Levee Mile Report Line	86
Start Levee Mile	12.23
End Levee Mile	12.30
Location	Land Side
Category	Earthen Levee
Item	Vegetation
Looking west at dense landscaping on landside shoulder and slope.	
richard_f_20130918_172.jpg

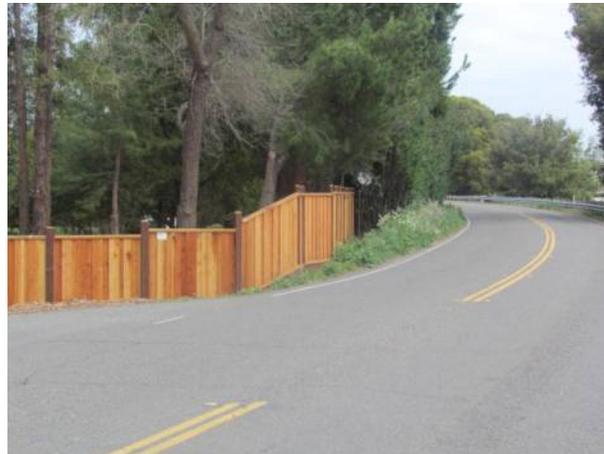
Levee Mile Report Line	87
Start Levee Mile	12.26
End Levee Mile	12.26
Location	Land Side
Category	Earthen Levee
Item	Encroachments
Looking northwest a new wooden fence on landside shoulder.	
richard_f_20130918_208.jpg

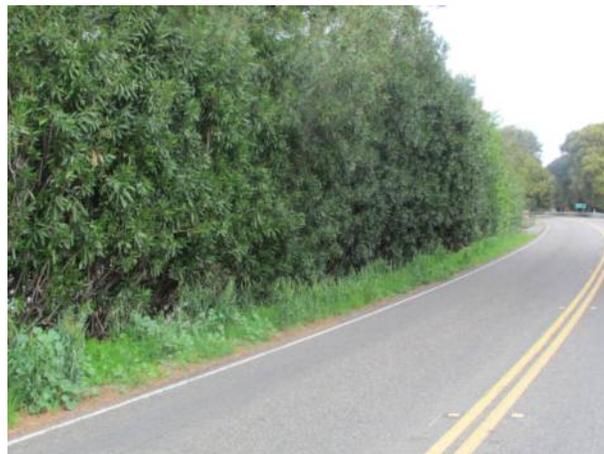
Levee Mile Report Line	88
Start Levee Mile	12.33
End Levee Mile	12.40
Location	Land Side
Category	Earthen Levee
Item	Vegetation
Looking northwest at oleander on landside shoulder.	
richard_f_20130918_173.jpg

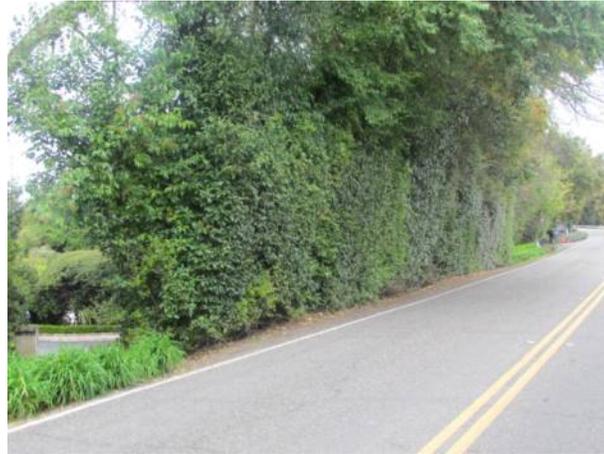
Levee Mile Report Line	89
Start Levee Mile	12.48
End Levee Mile	12.55
Location	Land Side
Category	Earthen Levee
Item	Vegetation
Looking northwest at dense landscaping on landside shoulder.	
richard_f_20130918_174.jpg

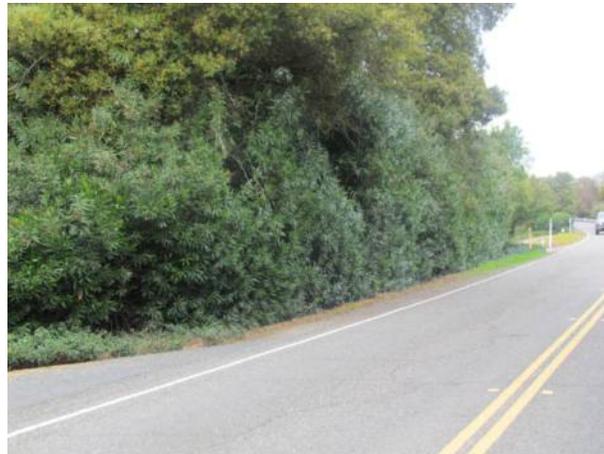
Levee Mile Report Line	91
Start Levee Mile	12.60
End Levee Mile	12.63
Location	Land Side
Category	Earthen Levee
Item	Vegetation
Looking northwest at dense landscaping on landside shoulder and slope.	
richard_f_20130918_175.jpg

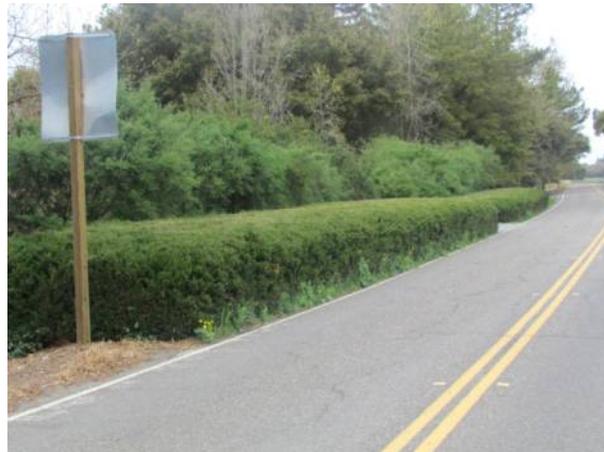
Levee Mile Report Line	92
Start Levee Mile	12.77
End Levee Mile	12.85
Location	Land Side
Category	Earthen Levee
Item	Vegetation
Looking northwest at dense landscaping on landside shoulder and slope.	
richard_f_20130918_176.jpg

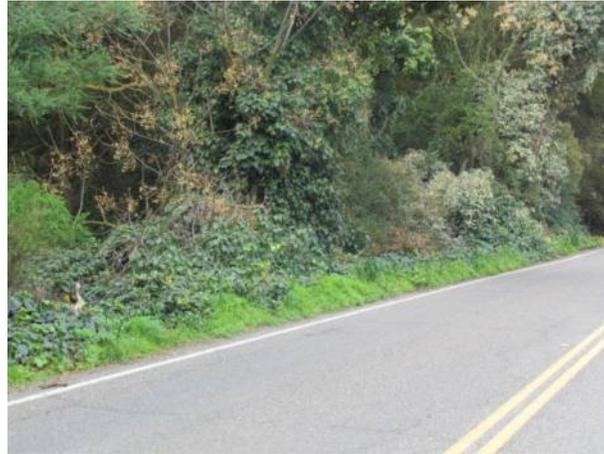
Levee Mile Report Line	94
Start Levee Mile	13.26
End Levee Mile	13.29
Location	Land Side
Category	Earthen Levee
Item	Vegetation
Looking west at dense landscaping on landside shoulder and slope.	
richard_f_20130918_199.jpg

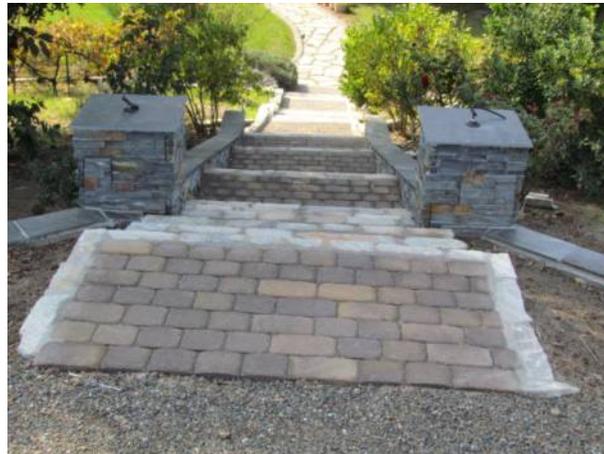
Levee Mile Report Line	95
Start Levee Mile	13.60
End Levee Mile	13.60
Location	Land Side
Category	Earthen Levee
Item	Encroachments
Looking west at stairs on landside slope.	
richard_f_20130918_153.jpg

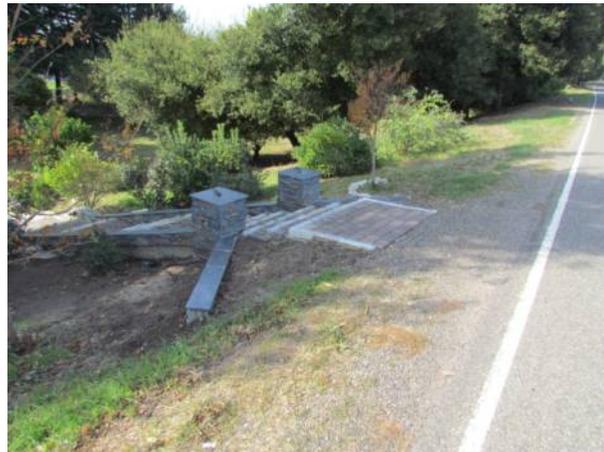
Levee Mile Report Line	95
Start Levee Mile	13.60
End Levee Mile	13.60
Location	Land Side
Category	Earthen Levee
Item	Encroachments
Looking northwest at stairs on landside slope.	
richard_f_20130918_154.jpg

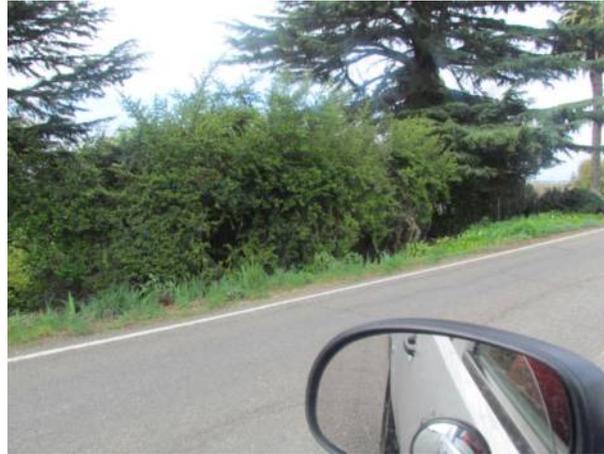
Levee Mile Report Line	99
Start Levee Mile	14.36
End Levee Mile	14.38
Location	Land Side
Category	Earthen Levee
Item	Vegetation
Looking west at landscaping on landside slope.	
richard_f_20130918_179.jpg

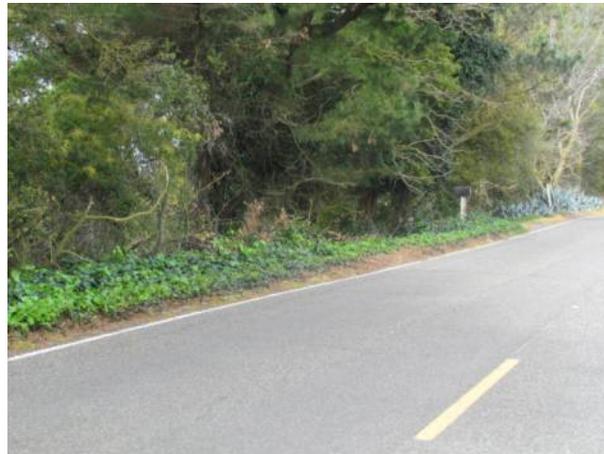
Levee Mile Report Line	102
Start Levee Mile	14.93
End Levee Mile	15.09
Location	Land Side
Category	Earthen Levee
Item	Vegetation
Looking northwest a dense landscaping on landside shoulder and slope.	
richard_f_20130918_188.jpg

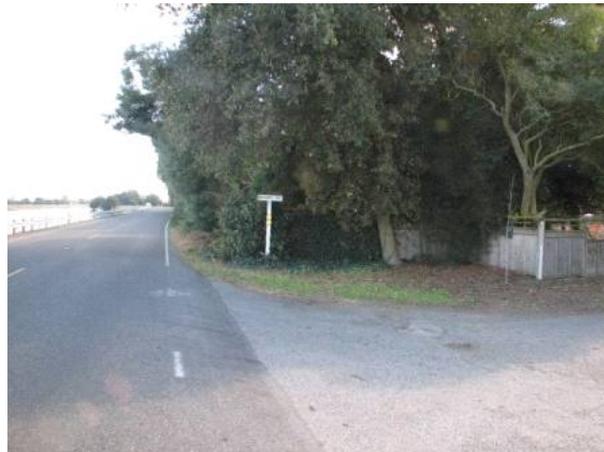
Levee Mile Report Line	105
Start Levee Mile	15.84
End Levee Mile	15.93
Location	Land Side
Category	Earthen Levee
Item	Vegetation
Looking south at landscaping on levee slope and toe obstruct access and visibility.	
richard_f_20130918_196.jpg

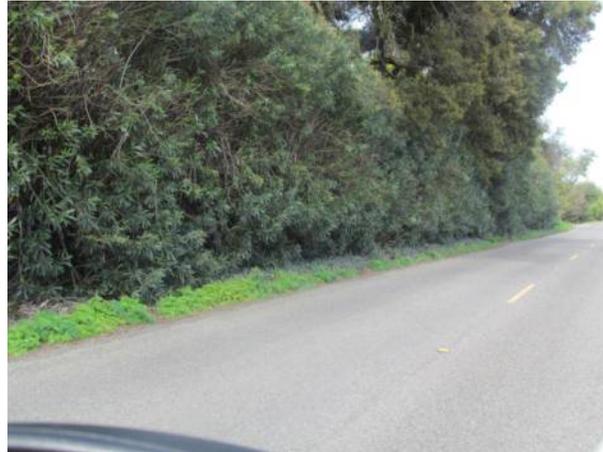
Levee Mile Report Line	105
Start Levee Mile	15.84
End Levee Mile	15.93
Location	Land Side
Category	Earthen Levee
Item	Vegetation
Looking northwest at dense landscaping on landside shoulder and slope.	
richard_f_20130918_197.jpg

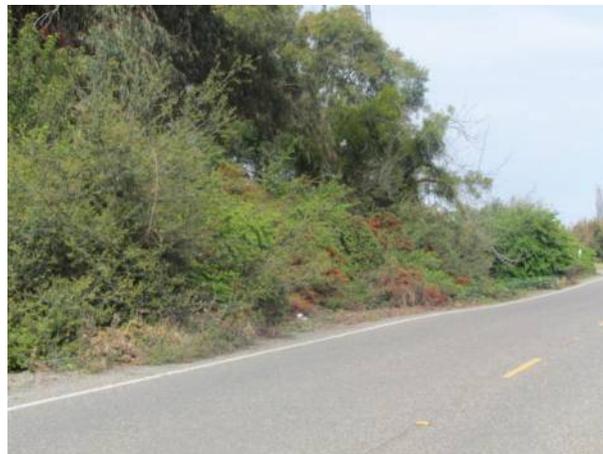
Levee Mile Report Line	107
Start Levee Mile	16.45
End Levee Mile	16.51
Location	Land Side
Category	Earthen Levee
Item	Vegetation
Looking west at dense landscaping on landside shoulder and slope.	
richard_f_20130918_183.jpg

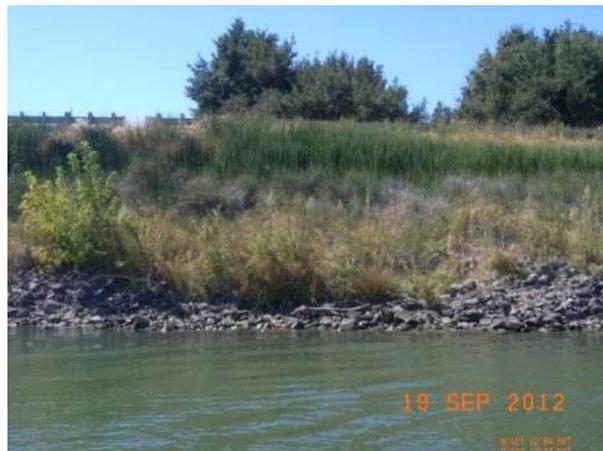
Levee Mile Report Line	108
Start Levee Mile	16.54
End Levee Mile	16.54
Location	Water Side
Category	Supplemental
Item	USACE Erosion Survey
USACE 2012 Photo #1	
USACE2013_SAC_31-6_R_1.jpg

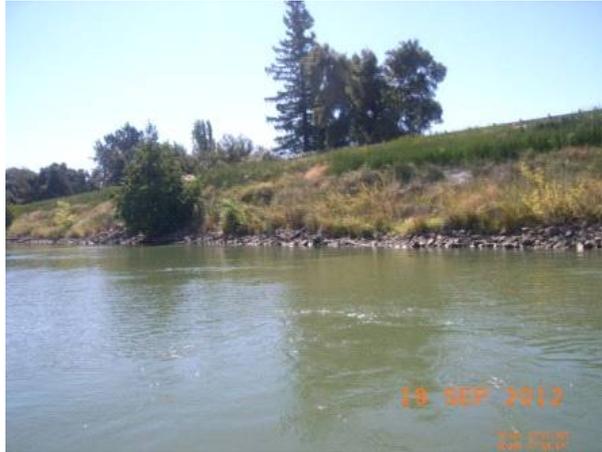
Levee Mile Report Line	108
Start Levee Mile	16.54
End Levee Mile	16.54
Location	Water Side
Category	Supplemental
Item	USACE Erosion Survey
USACE 2012 Photo #2	
USACE2013_SAC_31-6_R_2.jpg

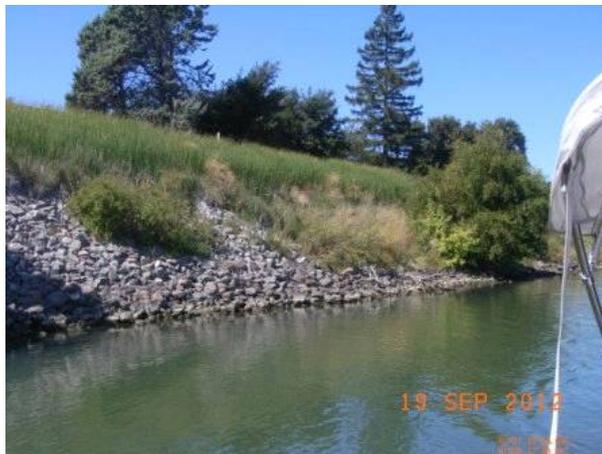
Levee Mile Report Line	108
Start Levee Mile	16.54
End Levee Mile	16.54
Location	Water Side
Category	Supplemental
Item	USACE Erosion Survey
USACE 2012 Photo #3	
USACE2013_SAC_31-6_R_3.jpg

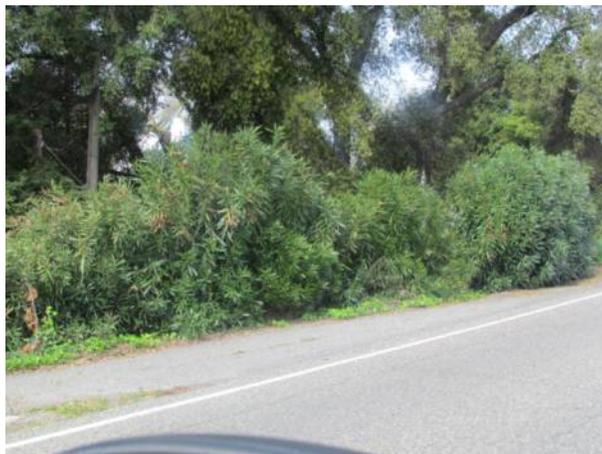
Levee Mile Report Line	109
Start Levee Mile	16.84
End Levee Mile	16.90
Location	Land Side
Category	Earthen Levee
Item	Vegetation
Looking west at landscaping on landside shoulder and slope.	
richard_f_20130918_194.jpg

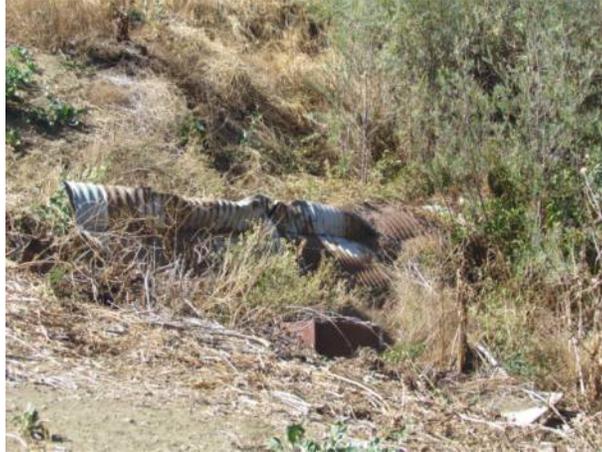
LMIR No.	Levee Mile		Category	Item	Location	Rating	Action/Comment	GPS Latitude/Longitude		Issue No. Photo
	Start	End						Start	End	
1	0.02	0.02	Earthen Levee	Encroachments	WS	M Ma	GA : Garbage Inspector Comments: Old corrugated pipe on waterward slope.	°	°	1 Y
DWR ID: DWR_RD0003_03_f_2013_1										
2	0.06	0.06	Earthen Levee	Slope Stability	LS	M Ma	S1 : Repair slope instability. Inspector Comments: Larger depression on landward slope.	38.181427 ° -121.653622 °	38.181427 ° -121.653622 °	3 Y
DWR ID: DWR_RD0003_03_s_2013_3										
3	0.08	0.43	Earthen Levee	Crown Surface / Depressions / Rutting	CR	M Ma	C3 : Add appropriate gravel or road base. Grade and compact.	38.181223 ° -121.653617 °	38.176118 ° -121.653765 °	4
DWR ID: DWR_RD0003_03_s_2013_4										
4	0.15	0.18	Earthen Levee	Trim / Thin Trees	WS	M Ma	T1 : Trim trees to at least five feet above ground level.	38.180150 ° -121.653645 °	38.179722 ° -121.653663 °	5

Levee Mile Report Line	1
Start Levee Mile	0.02
End Levee Mile	0.02
Location	Water Side
Category	Earthen Levee
Item	Encroachments
Looking southeast at old corrugated pipe on waterward slope.	
richard_f_20131003_058.JPG

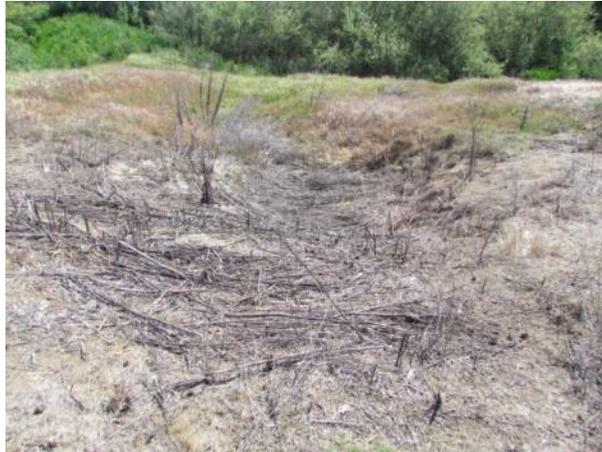
Levee Mile Report Line	2
Start Levee Mile	0.06
End Levee Mile	0.06
Location	Land Side
Category	Earthen Levee
Item	Slope Stability
Looking north on depression on landward slope.	
richard_f_20130918_210.JPG

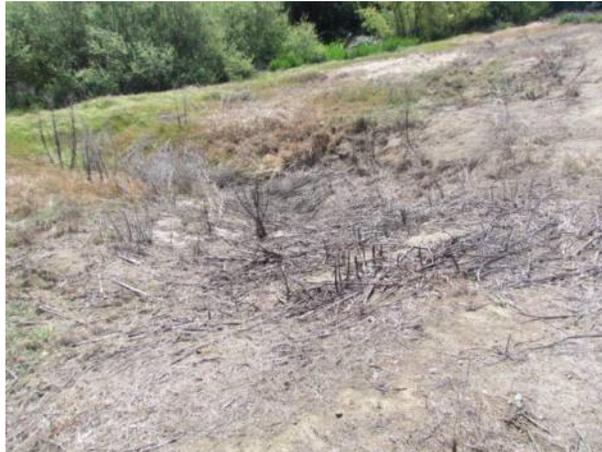
Levee Mile Report Line	2
Start Levee Mile	0.06
End Levee Mile	0.06
Location	Land Side
Category	Earthen Levee
Item	Slope Stability
Looking east at depression on landward slope.	
richard_f_20130918_211.JPG

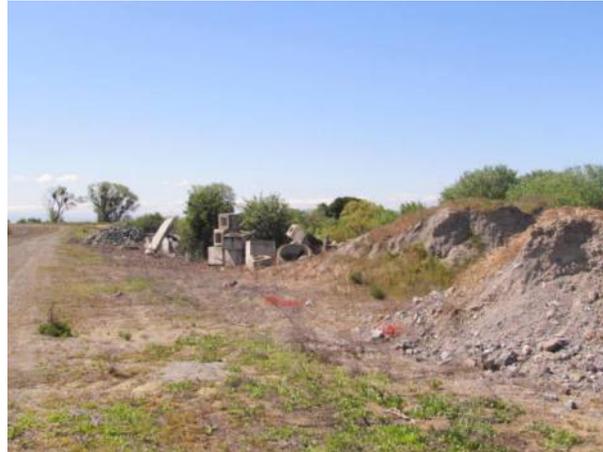
Levee Mile Report Line	5
Start Levee Mile	0.26
End Levee Mile	0.30
Location	Water Side
Category	Earthen Levee
Item	Encroachments
Looking east at concrete rubble and other material stored on landward shoulder and slope.	
richard_f_20130918_212.JPG
